Biofouling in marine environments is one of the primary limiting factors that will determine the deployment duration of platforms and instrumentation and dictate the service schedule that is required. ClearSignal, manufactured by Severn Marine Technologies, is a clear, non-toxic coating, that resists biofouling. The product acts as a durable, permanent, foul-release coating that is designed to last the life of the equipment it is protecting. Its effectiveness is a result of the non-stick properties of the materials in the proprietary coating. Unlike traditional antifouling systems which rely on active biocides and whose effectiveness degrades with time, ClearSignal retains its effectiveness over time.

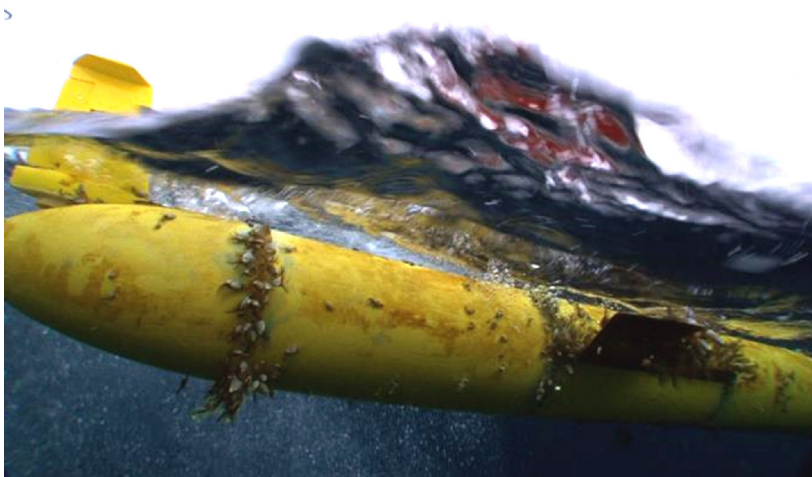
Photo of the Rutgers University's Scarlett Night Glider on its historic Atlantic crossing. Image shows barnacle-free areas where ClearSignal had been applied along with adjacent areas not treated. These non-treated areas at the seams of the glider's modular segments had, over time, bio-accumulations of barnacle.
